**Seismic Analysis of a Retrofitted Reinforced Concrete Building in
Mexico City**

Thesis

The University of Texas at Austin

August 2019

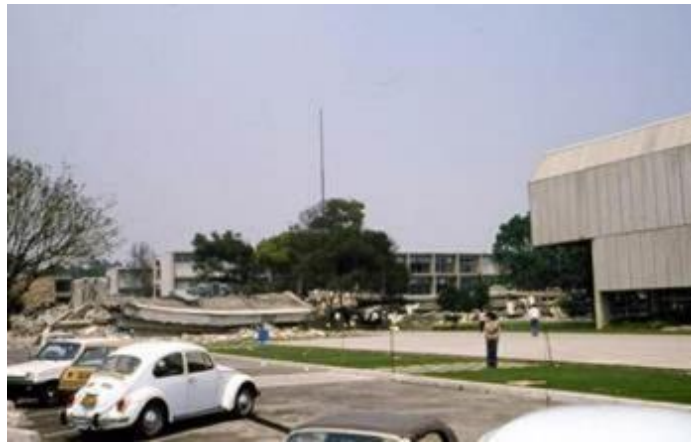
Mexico City has a long history of seismic activity with the most severe earthquakes in recent history occurring in 1979, 1985 and 2017. In March 1979 a 7.4-magnitude earthquake resulted in the collapse of the Universidad Iberoamericana (Fig 1.1) and the loss of electrical power in 20% of the Mexican territory (El Pais, 1979). While the material losses were high, only five people lost their lives during the event.

Figure 1.1: Photo of the collapsed buildings from the Universidad Iberoamericana (IBEROMX, 2017)

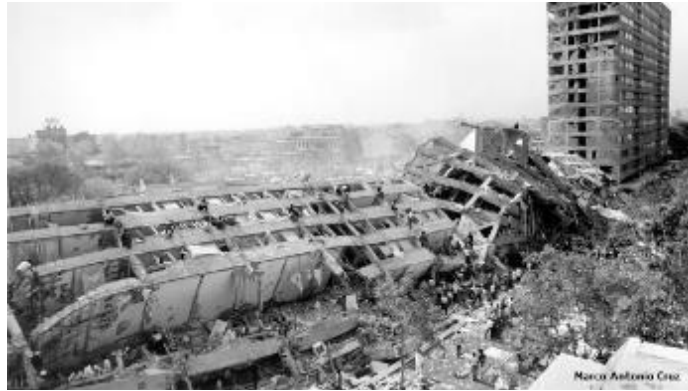
In contrast, the 8.1-magnitude 1985 Mexico City earthquake caused over 10,000 deaths and resulted in collapse and damage of modern construction that had not been seen before (Fig. 1.2). In the months and years following this earthquake, there was an unparalleled effort to repair and retrofit concrete buildings.

Figure 1.2: Collapsed building in Tlatelolco after the 1985 earthquake (BBC, 2017)

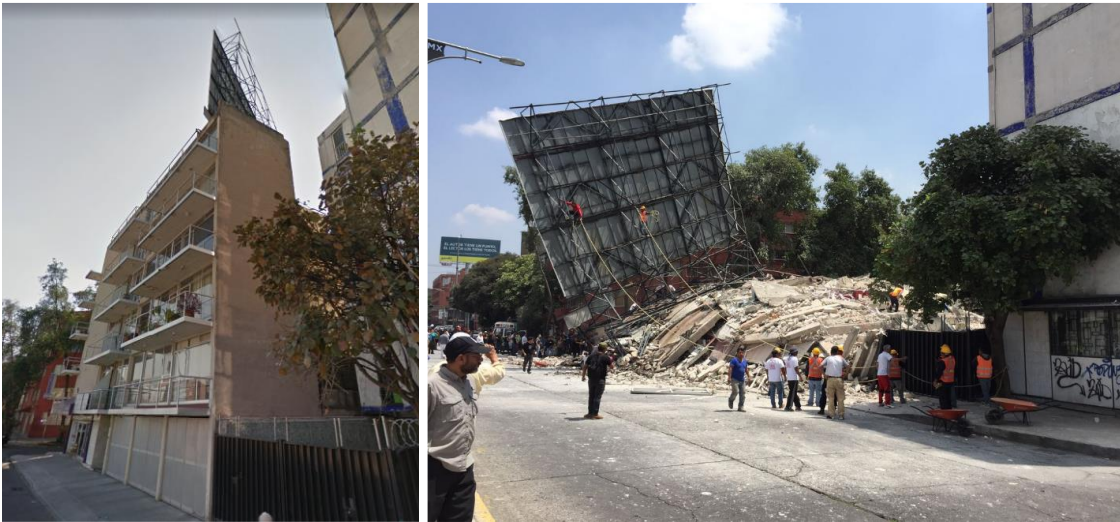
Figure 1.3: Building in Viaducto Aleman: Google street view before the 2017 earthquake (left), collapsed building after the event (right) (The Huffpost, 2017)

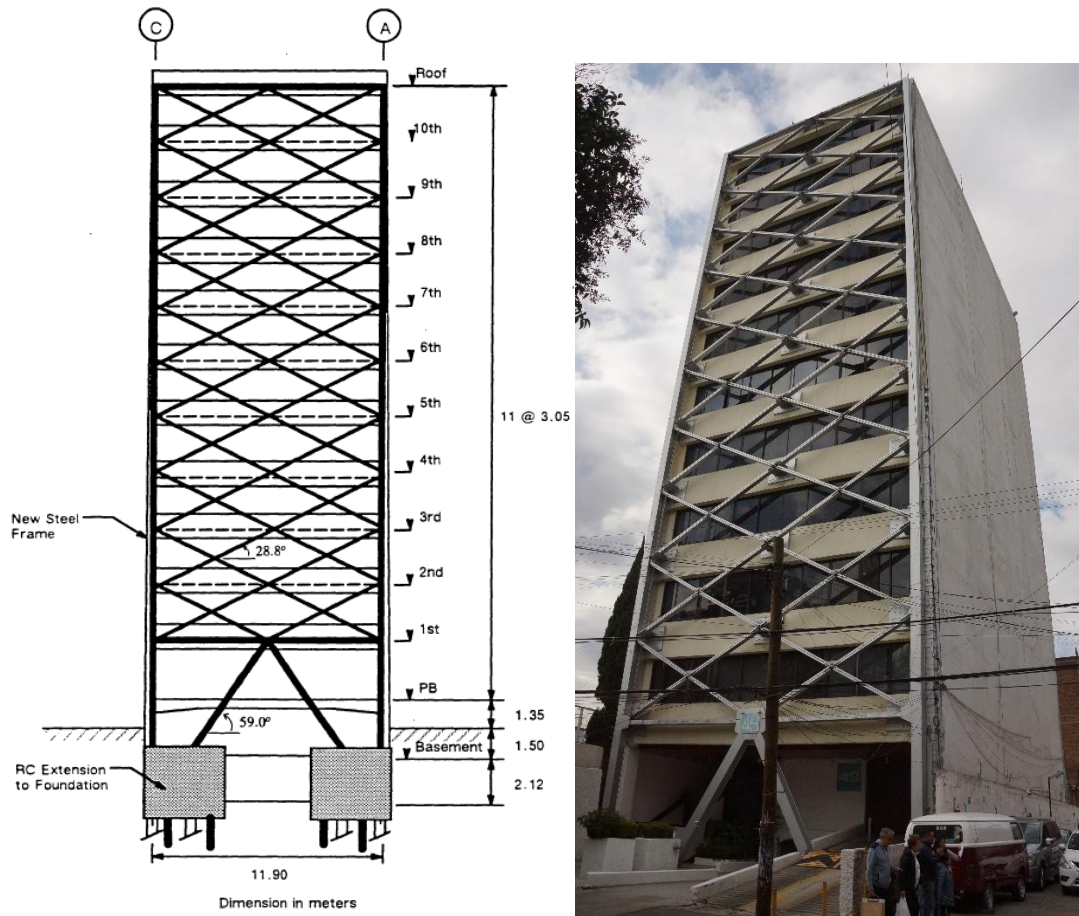
Figure 2.13: Elevation of Frame 5 after retrofit (Downs, et al., 1991) alongside a view of the southeast corner of the building

As mentioned above, the retrofit included a new steel frame added to both façade Frames (1 and 5). The frame elevation is presented in Fig. 2.13, while the extension to the foundation is shown in Fig. 2.14. The built-up box columns of these steel frames, through the 4th story, and the diagonal bracing at the 1st level were fabricated with 5/8" A36 steel plates. The rest of the columns use 1/2" A36 plates. The rest of the diagonal bracing consisted of two channels welded together forming a box. These were later connected to the structure using gusset and stitch plates. Two C8x11.5 A36 channels were used up to the 7th story, while two C6x8.2 A36 channels are used in the rest of the stories. The extension to the foundation consisted of footings measuring 3.53 m (~11.6 ft) x 1.50 m (~4.9 ft) and 2.64 m (~8.7 ft) in depth. Each footing is connected to three steel piles of 77 mm (3 in) in diameter and 25 m (~82 ft) in length. To properly attach the steel frame to the

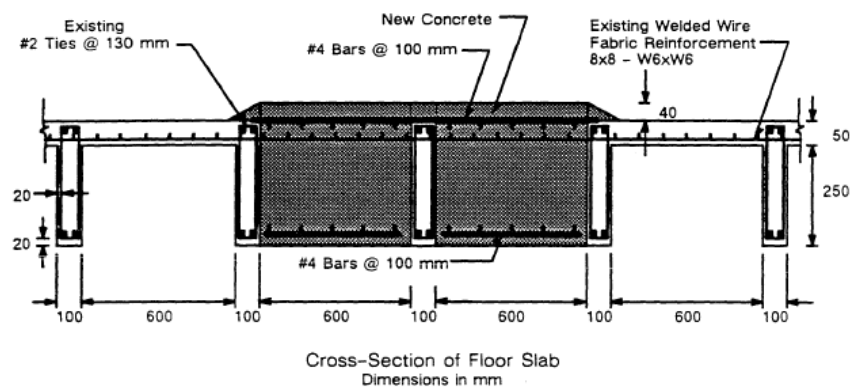
Figure 2.15: Detail of typical slab reinforcement at locations of steel frame attachment to Frames 1 and 5 (Downs, et al., 1991)

existing concrete structure the floor system was reinforced midspan as shown in Figure 2.15. In the corners connections as the ones presented in Figure 2.16 were added.

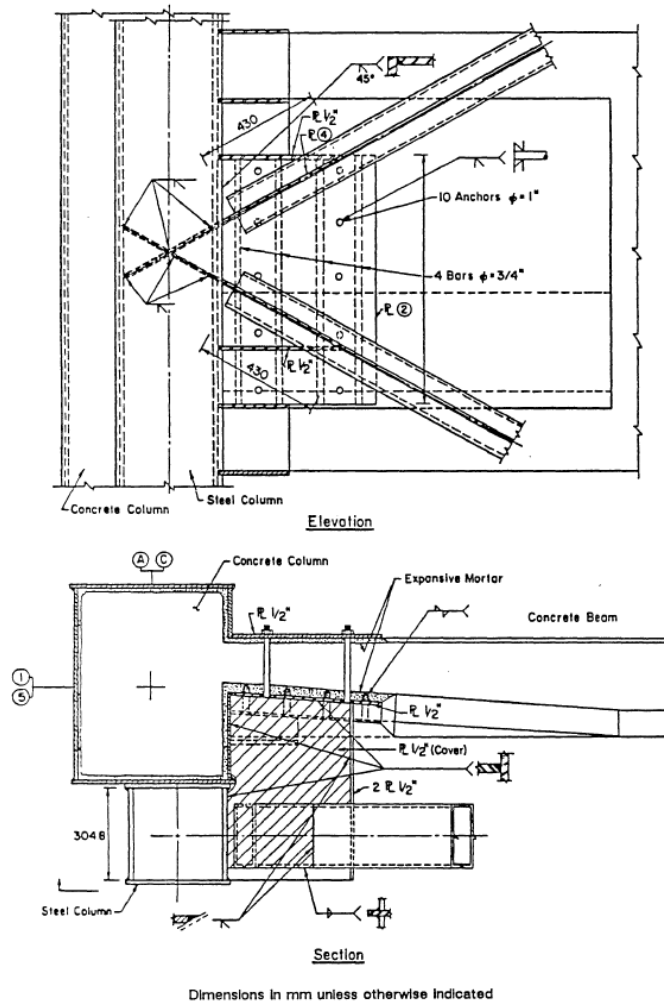
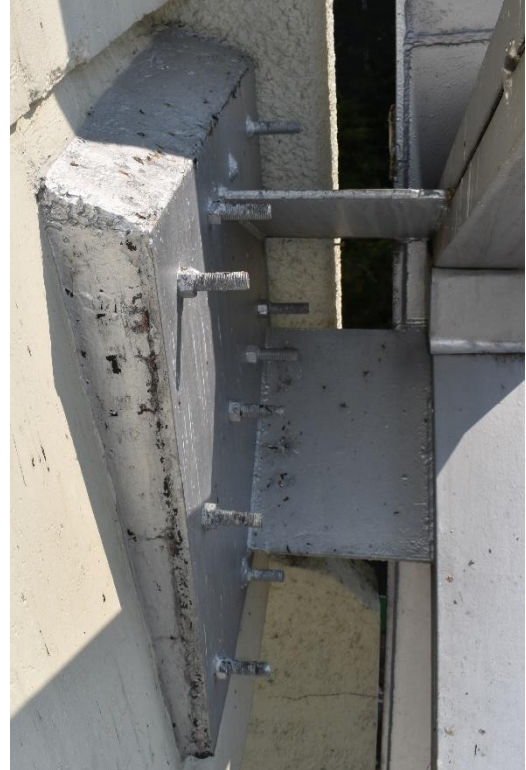
Figure 2.16: Typical detail for attachment of new steel frame to existing concrete frame (Downs, et al., 1991) alongside a view of the connection

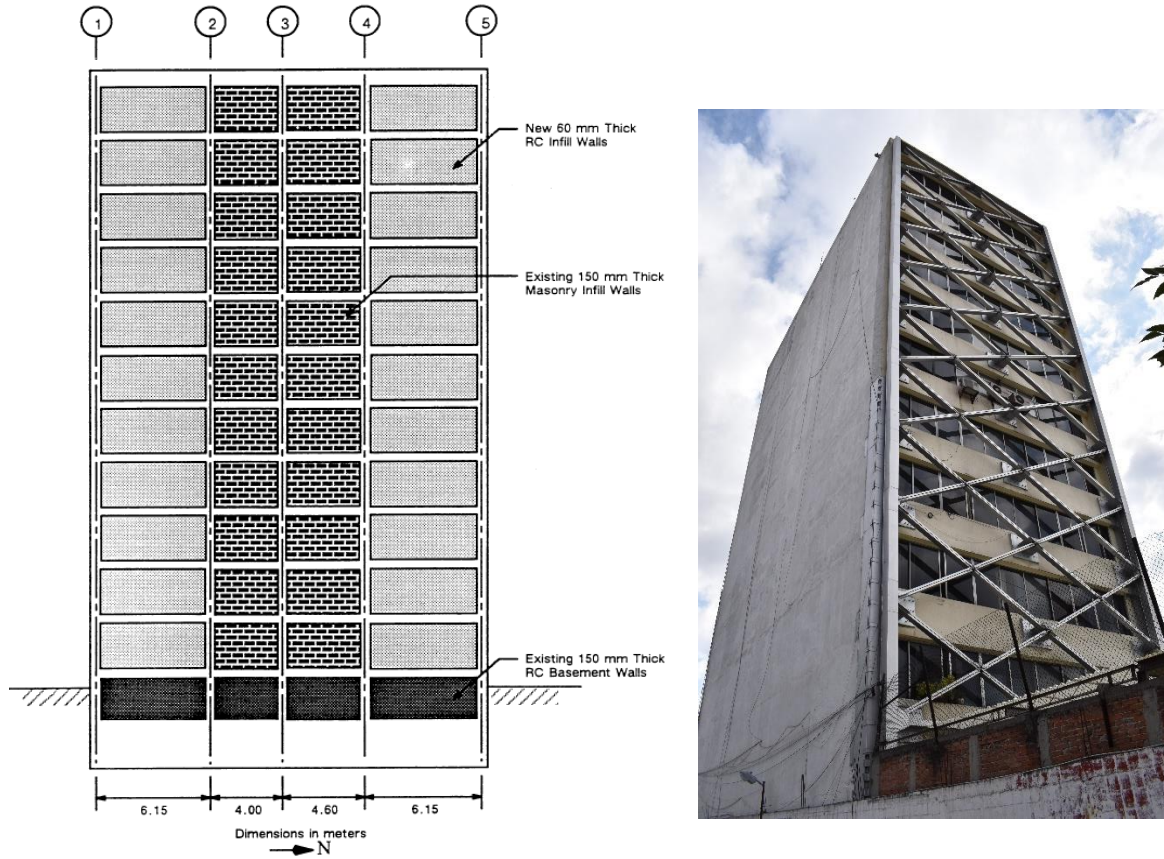
Figure 2.17: Elevation of Frame C showing new RC infill walls (Downs, et al., 1991) alongside a photo of the southeast corner of the building

After the retrofit, the building has been subjected to three major earthquakes. The first one being the 19 September 1985 with a magnitude of 8.1. During this event, the building suffered no visible damage with only slight cracking in the new RC infill walls according to Downs et al. (1991).

RC infill walls were added to bays 1-2 and 4-5 of Frames A and C to strengthen the longitudinal direction (N-S) as shown in Fig. 2.17. These infills, measuring 60 mm (~2.4 in) in thickness, were connected to the existing masonry infills, columns and beams using nails, while the Celotex was removed and the gap filled with mortar (Fig. 2.18). The vertical and horizontal reinforcement ratios of the RC infill walls were 1.27% in stories 1-4, 0.64% in stories 5-7, and 0.42% in stories 8-10. While no information is reported about
